**City of Thomasville Stormwater Action Plan/
Stormwater Master Plan:**

*Part I – Watershed Prioritization, Drainage System Assessment &
City Codes/Policies Review*

City of Thomasville, Georgia

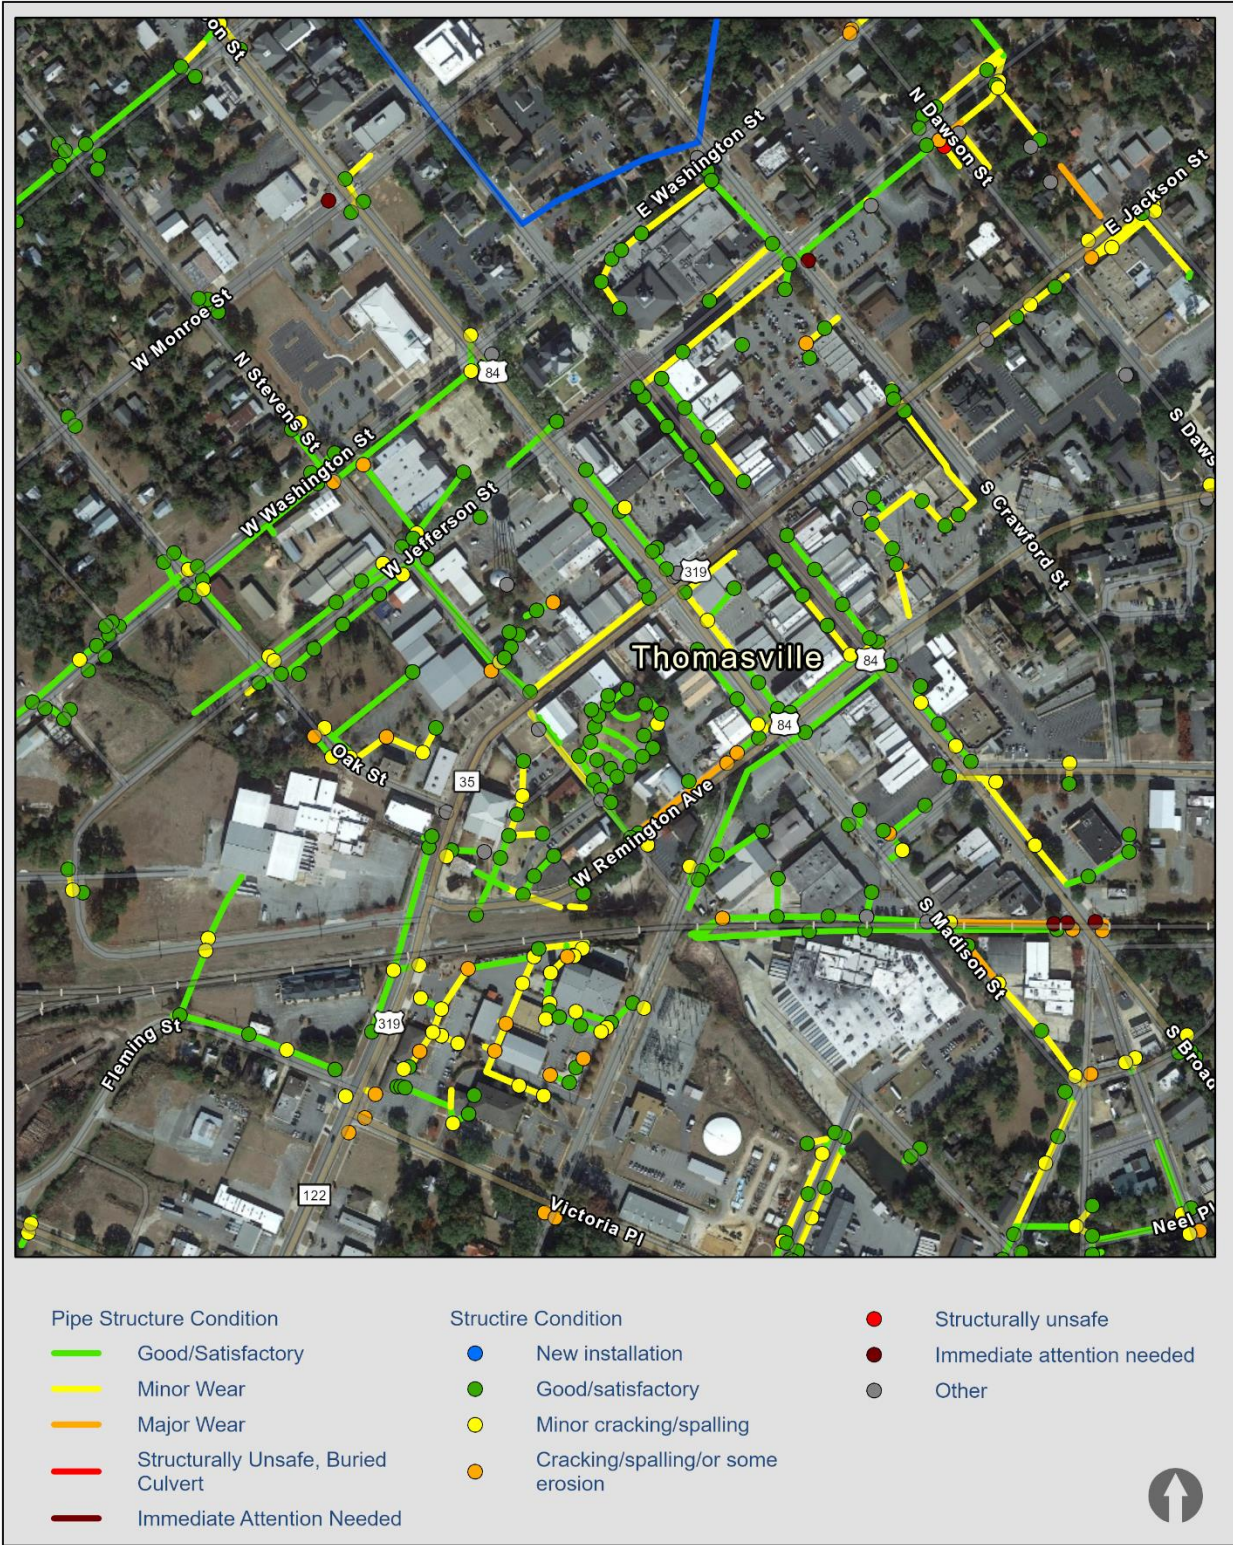
Figure 2.3: Example Results Associated with Structural Damage in Pipes and Inlets.

A few examples of the condition assessment data that have similar maintenance needs (e.g., structural damage or sedimentation) are presented in the figures on the subsequent pages. In each of these, the ratings are color coded, where green is in good condition, and the severity of the issue increases as the color changes to yellow, orange, red, and dark red. Figure 2.3 includes the results from the structural condition fields for inlets and pipes in a section of the pilot area in downtown. This visual display highlights where the most pressing needs are for structural repair. Figure 2.4 includes the results for presence of sediment in inlets and pipes for the same geographic area. Figure 2.5 includes a summary of the most pressing needs for sediment removal in stormwater inlets and pipes in the downtown pilot study area. Only inlets and pipes that have maintenance needs of medium (orange) or worse (red or dark red), are presented in this figure.
